Titanic's Antifouling Paint

By Bob Read, D.M.D.

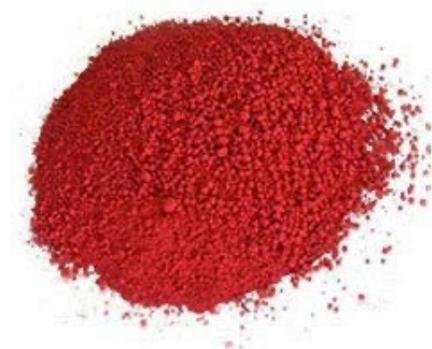
The specific color of Titanic's Suter Hartmann Rahtjens antifouling paint is a function of the individual ingredients. Figure 1 shows the appearance of powdered mercuric oxide.

Mercuric oxide

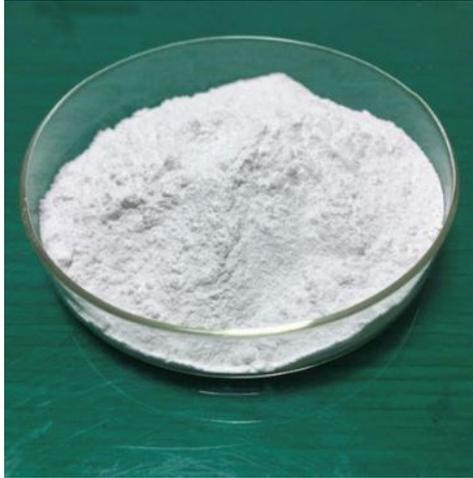
Figure 2 shows the color of powdered arsenic.

Arsenic

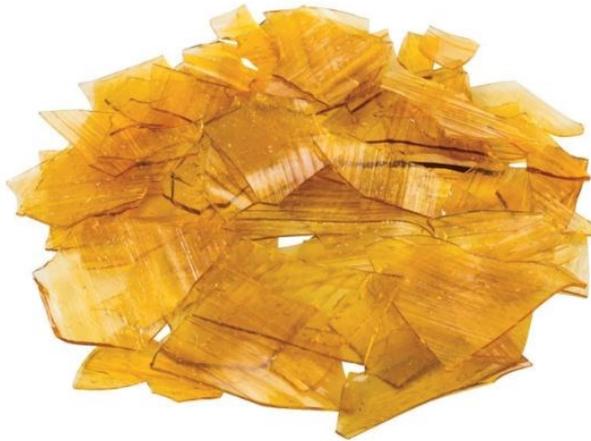
Figure 3 shows shellac flakes.

Shellac flakes

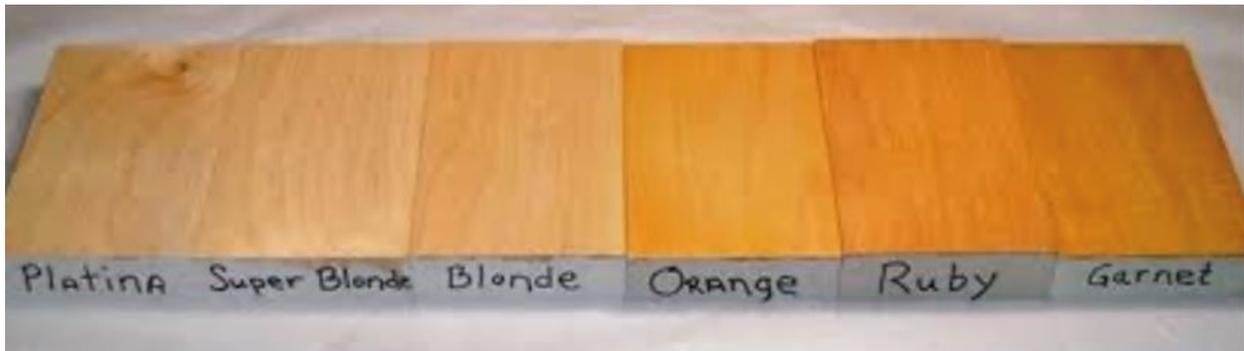
Figure 4 shows a range of variation of shellacs applied to wood.

Range of shellac shades

So, with the possibility of a variation of the color of most of the ingredients in the Suter Hartmann Rahtjens paint formula, it is not possible to determine the color just from the ingredients. Additionally, mercury based antifouling paints are no longer legal so we can't look at contemporary examples.

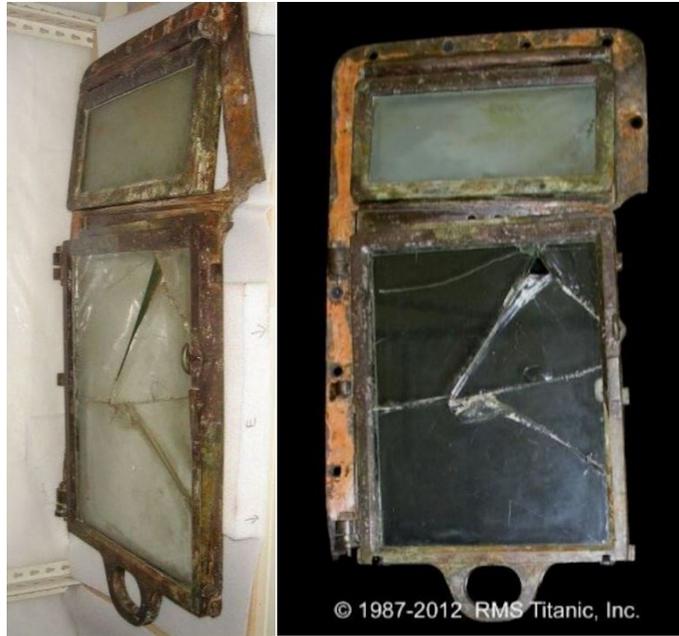
In the early 2000s one of Titanic's officers' quarters windows was recovered. It was a brass framed window which still had some adhering paint. Over a period of a year conservation techniques were performed on the window. Figure 6 shows the window before conservation procedures on the left and after these procedures on the right.

Before and after conservation procedures on
Titanic officers' quarters window

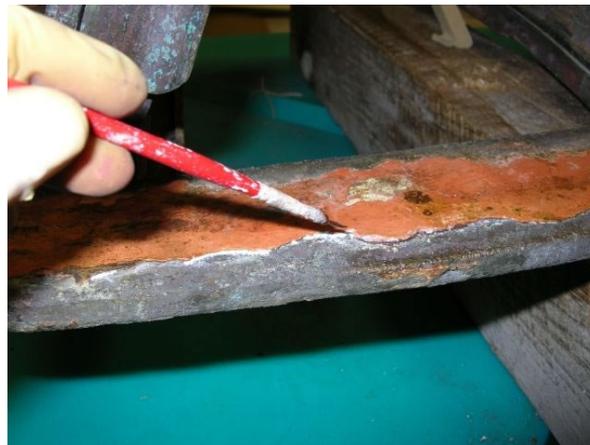
Figure 7 shows a close-up of the restored paint adhering to the window frame.

Restored paint on Titanic's
Officers' quarters window

From other evidence we know this color to be "dark mast". For a full examination of is color, it was described here: [Examination of the Color Dark Mast](#)

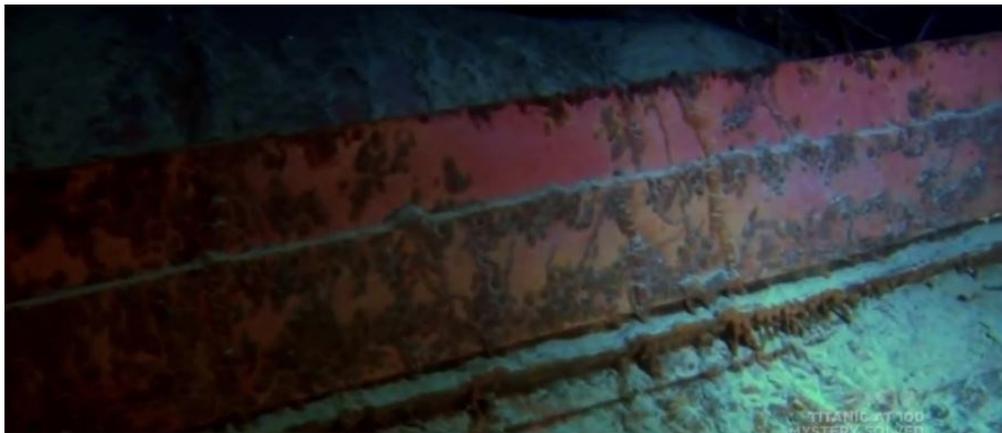
Figure 8

The exception to the extreme darkening of these painted surfaces has been found to be on the surfaces painted with antifouling paint. Figures 8 – 10 show several photos with acceptable lighting clearly showing antifouling paint on Titanic’s hull.

Titanic antifouling paint

In all of these photos we can see that within the paint is the formation of rusticles emanating from the underlying steel. This rusticle formation may affect the color of the paint in the photos.

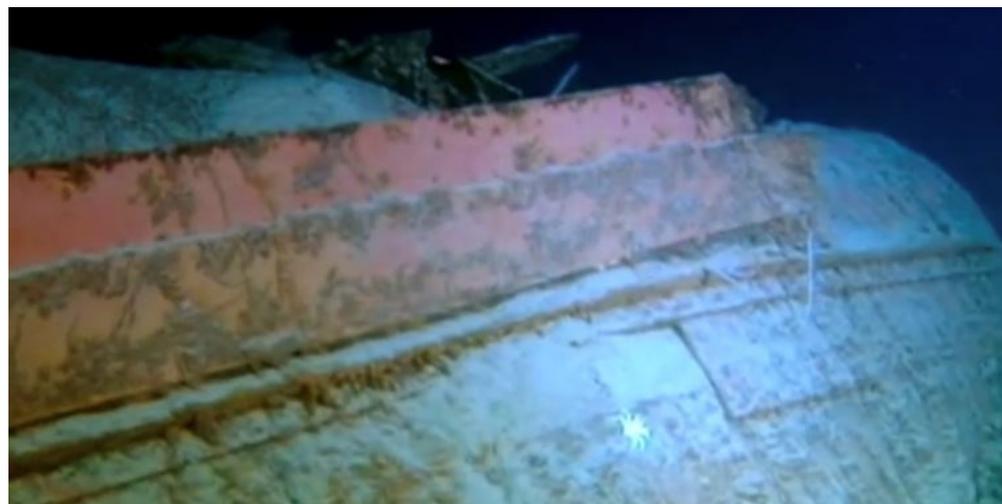
Figure 9

Titanic antifouling paint

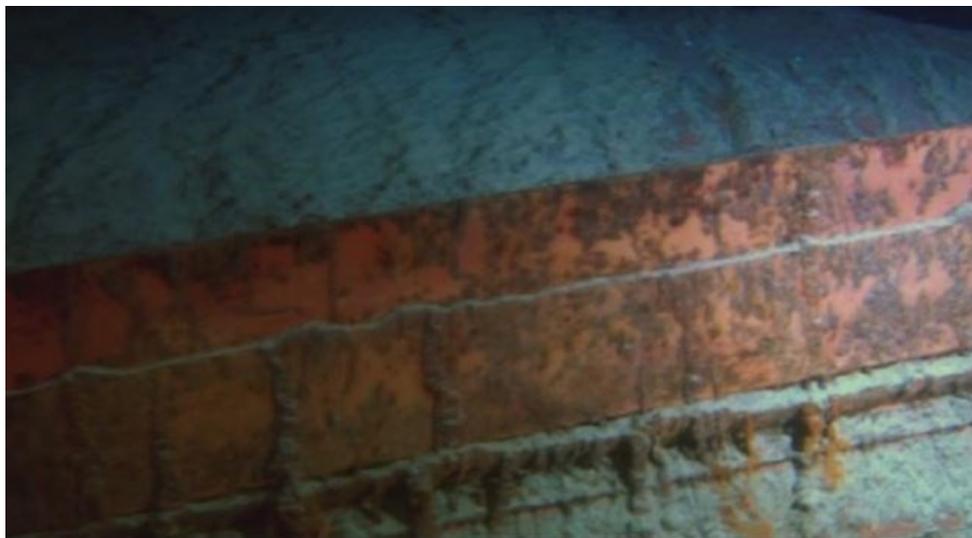
Figure 10

Titanic antifouling paint
