Titanic's Antifouling Paint

Introduction

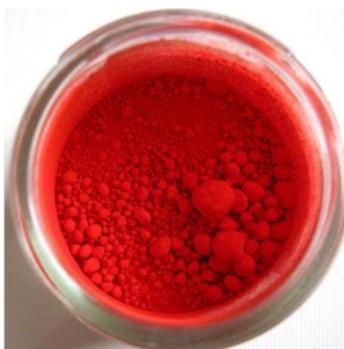
Figure 1

Mercuric Oxide

One of the most important factors in deciding the color of the paint is knowing how it was made. The ingredients of the formulation are mercuric oxide and cuprous oxide (based on a report from the US Navy in 1906, the mix ratio will be assumed at 50/50). Also mixed into the formulation was powdered arsenic. The toxics were the arsenic and mercuric oxides. The same report from the United States Navy points out Arsenic had zero effect in the paint as a toxicity agent. Regardless of whether Arsenic was used is relatively irrelevant. The solubility of arsenic is such that it will simply have no tonal effect on the paint. With this information a gradient can be done. That gradient is shown in Figure 3.

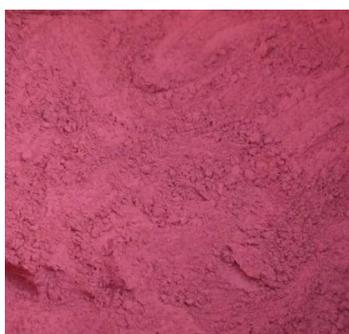
Figure 2

Cuprous Oxide

This wing propeller does not show an exact shade as a result of the previously mentioned chemical degradation process. This means that the shade will resemble the color of cuprous oxide more than the mercuric, as most of the mercuric is no longer there. Looking at the cuprous oxide sample in Figure 2, one can see the fairwater cap on the propeller is quite like the cuprous oxide. To adjust for this, you need to look at the gradient, and add more mercuric oxide to the gradient. The result is a maroon red color. This aligns with the 50/50 mix ratio mentioned previously.

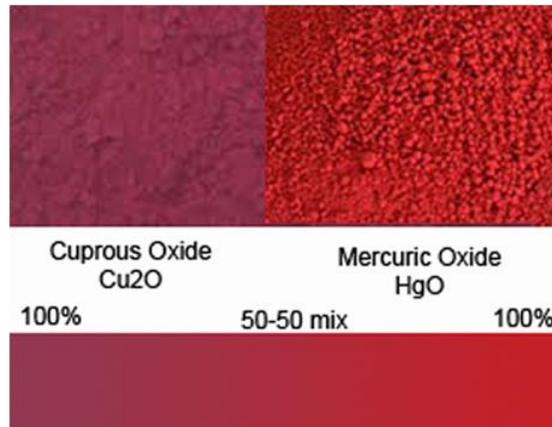
Figure 3

Gradient of the Two Oxides

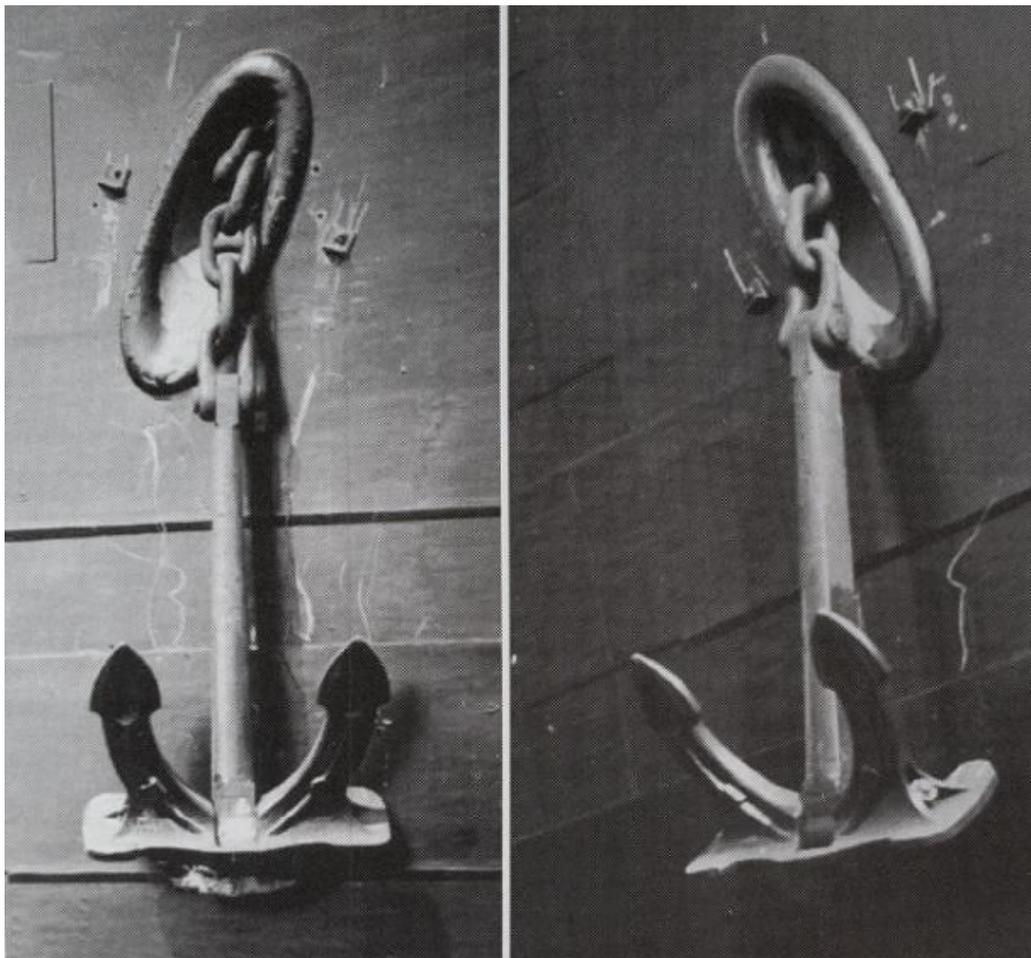
Figure 4

A Look Inside the Anchor Hawsers

antifouling mixture itself. This process doesn't affect the tonality of the final coat. However, it is relevant to where it has been long assumed was applied in the port and starboard anchor hawsers. The final 2 coats of the shellac and antifouling were not applied in the hawsers. This means that the color of paint inside the hawsers would be the sienna colored red oxide, or red lead, as opposed the antifouling. The forward anchor hawse pipe was painted with a light grey, nearly white color.

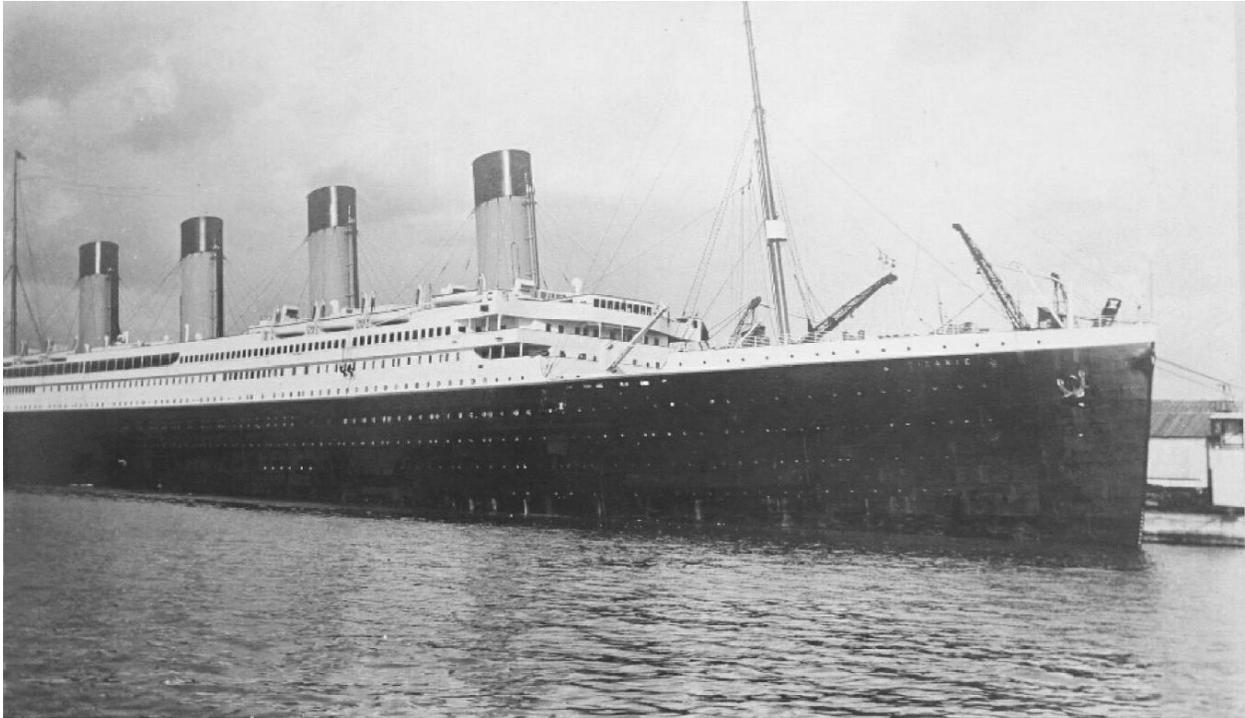
Figure 5

Titanic at Southampton. Note the Light Color Inside the Forward Hawser/Hawse Pipe

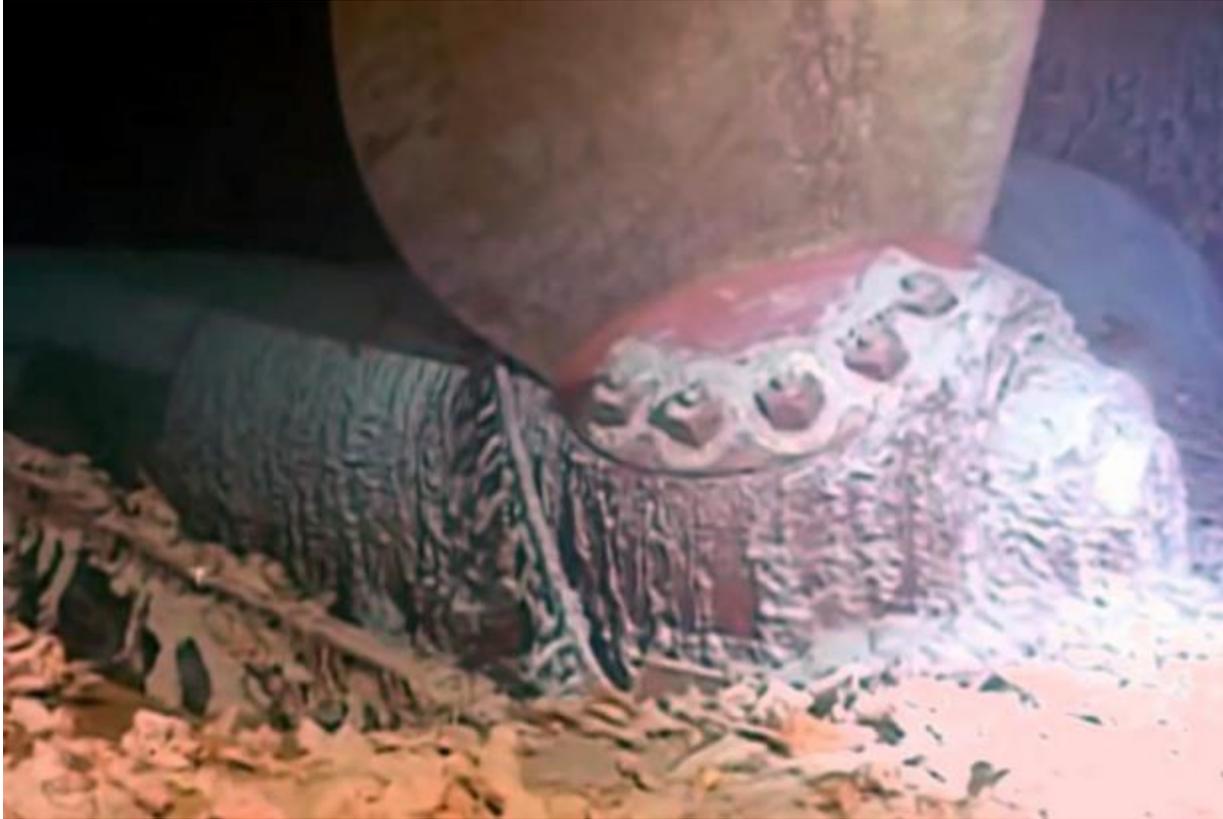
Figure 6

Titanic's Port Wing Propeller

Titanic's wreck could shed some light on the tone. However, before we continue, it is we must consider that the paint on the wreck should not be considered the exact shade. The reason is because of chemical degradation. In simple terms, this will result in the mercuric oxide to "eat" away, leaving behind the purple/pinkish mercuric oxide. It is accepted that a full spectrum photograph of the Titanic yields the most favorable results, so, for the sake of argument, full spectrum photos only.

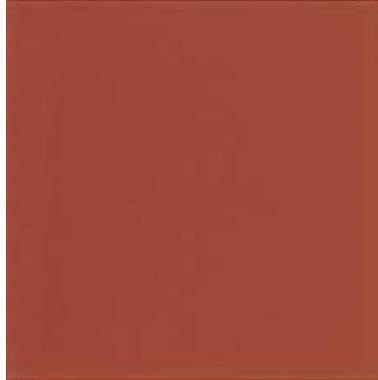
Figure 7

Red Lead Color Sample. Applied inside the port and starboard anchor hawsers

Hex: #a1493b

Red lead is a common anticorrosive substance. It is a formulation from red oxide. It takes on a somewhat sienna color. White shellac is achieved by simply bleaching out the yellow from normal gum shellac. In turn, it's a clear application. While shellac is a resin, it can be turned into liquid, which was applied after the coats of red lead. Finally for the lower hull was the
